SERMA TECHNOLOGIES

**HAMAMASTSU PHOTODIODES
(DPD - S8576)
EVALUATION N° 2
(GLAST Project)
REPORT E02P0638 - JULY, 2002**

**CEA
Orme des Merisiers
Bâtiment 709
91191 GIF-SUR-YVETTE**

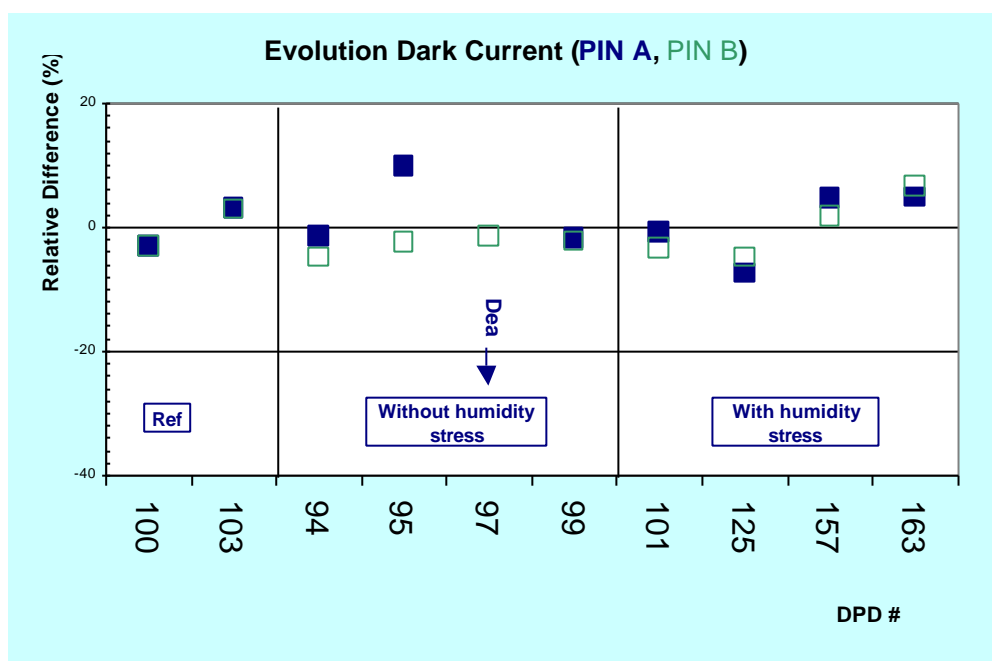
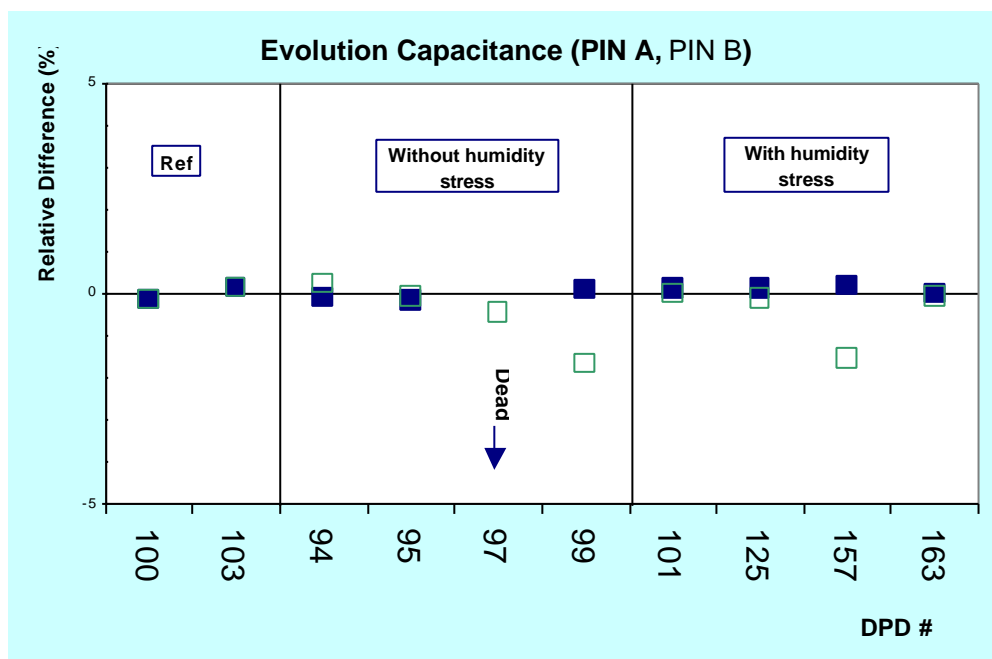
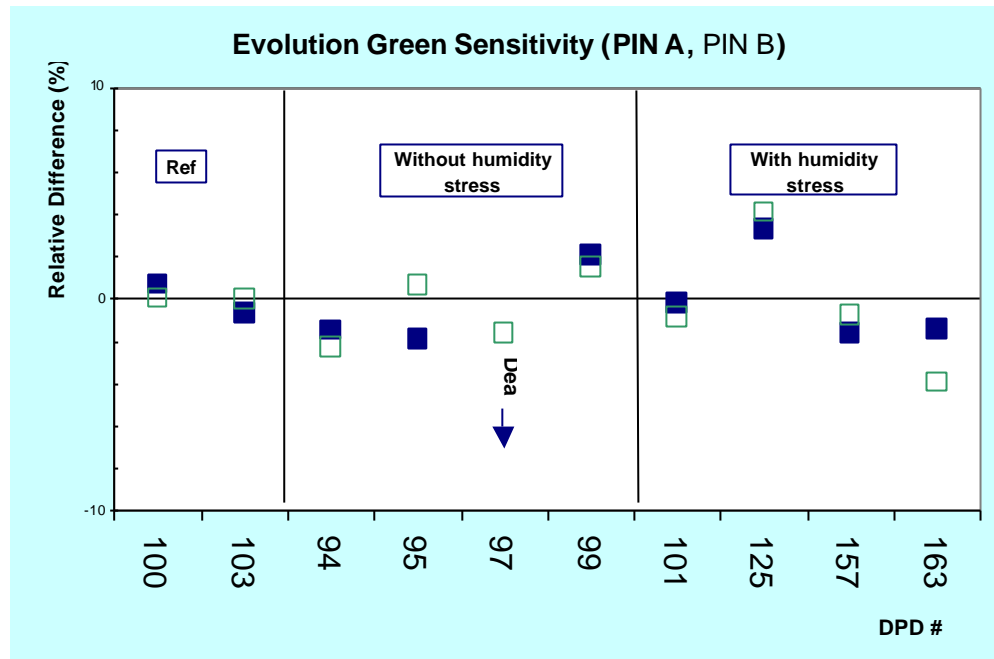
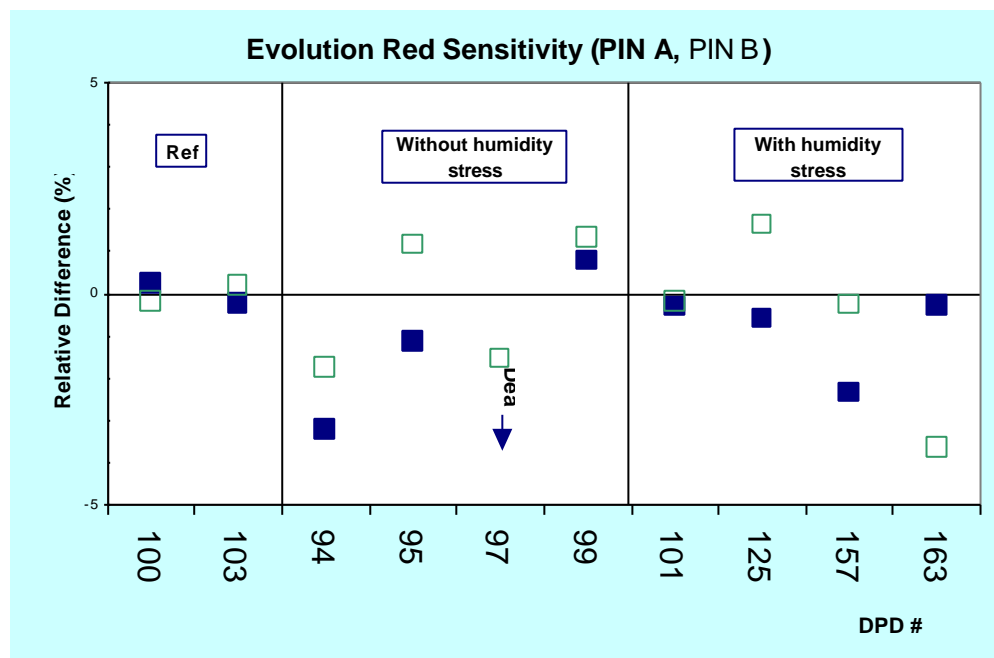
The results are summarized in the following tables and graphs.

The electrical and optical measurements show no evolution of the DPD characteristics apart for the PIN A (smaller die) of the part #97 which gave no signal at the end of the evaluation.
